**DEPARTMENT OF TRANSPORTATION**

Contract #: 04-0120F4Cty: SF/ALA Rte: 80 PM: 13.2/13.9File #: 69.28**WELDING INSPECTION REPORT****Resident Engineer:**Siegenthaler, Peter**Address:** 333 Burma Road**City:** Oakland, CA 94607**Report No:** WIR-020803**Date Inspected:** 19-Feb-2011**Project Name:** SAS Superstructure**OSM Arrival Time:** 700**Prime Contractor:** American Bridge/Fluor Enterprises, a JV**OSM Departure Time:** 1900**Contractor:** Zhenhua Port Machinery Company, Ltd (ZPMC), Changxing Island **Location:** Shanghai, China**CWI Name:** Zhou Zhong Hai**CWI Present:** Yes No**Inspected CWI report:** Yes No N/A**Rod Oven in Use:** Yes No N/A**Electrode to specification:** Yes No N/A**Weld Procedures Followed:** Yes No N/A**Qualified Welders:** Yes No N/A**Verified Joint Fit-up:** Yes No N/A**Approved Drawings:** Yes No N/A**Approved WPS:** Yes No N/A**Delayed / Cancelled:** Yes No N/A**Bridge No:** 34-0006**Component:** OBG Segments**Summary of Items Observed:**

## WELDING INSPECTION REPORT

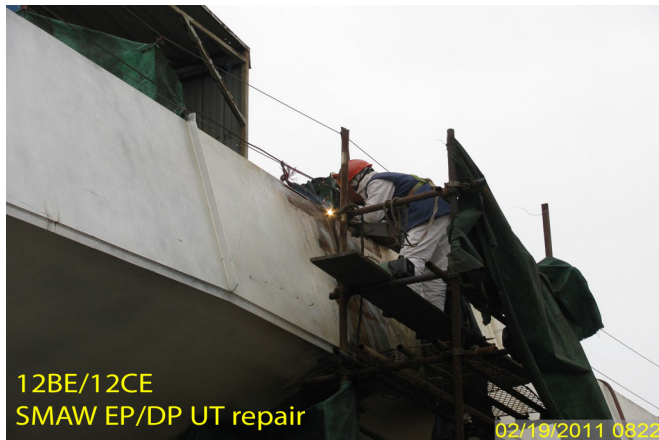
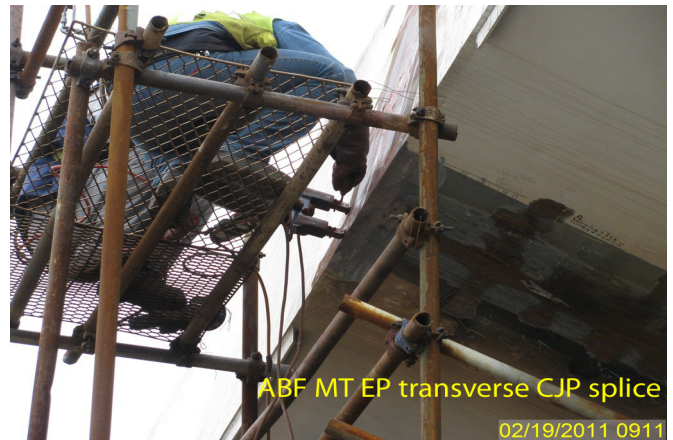
This QA Inspector observed ABF personnel performing Magnetic Particle Testing on the Edge Plate transverse CJP splice including locations of removed fit up plates, cross beam side.

Unless otherwise noted, all work observed on this date appeared to generally comply with applicable contract documents.
